GUIDELINES FOR REPAIR AND MAINTENANCE OF BRIDGE COATINGS: OVERCOATING

Guidelines for Repair and Maintenance of Bridge Coatings: Overcoating

PUBLICATION NO. FHWA-RD-87-092

AUGUST 1997

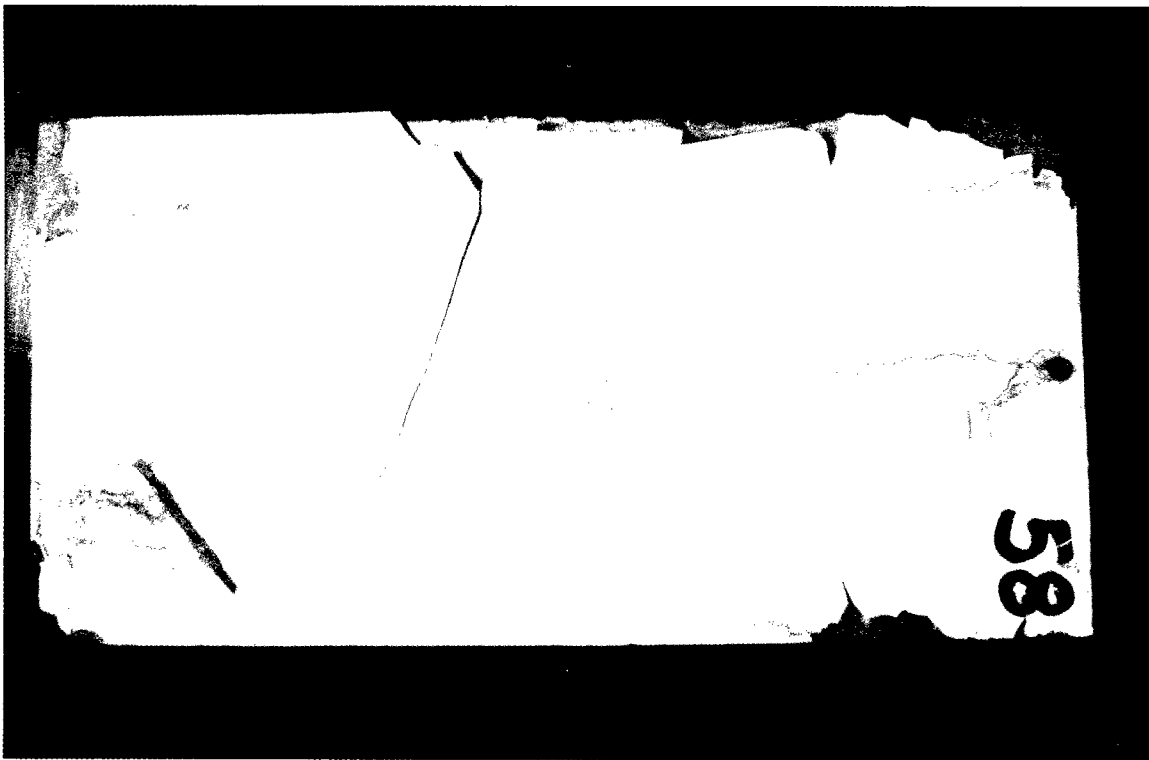
Figure 8. System E (Al-MCU/urethane/urethane) applied over 6 week old alkyd following the cyclic test. The soft alkyd disbonded within the coating.

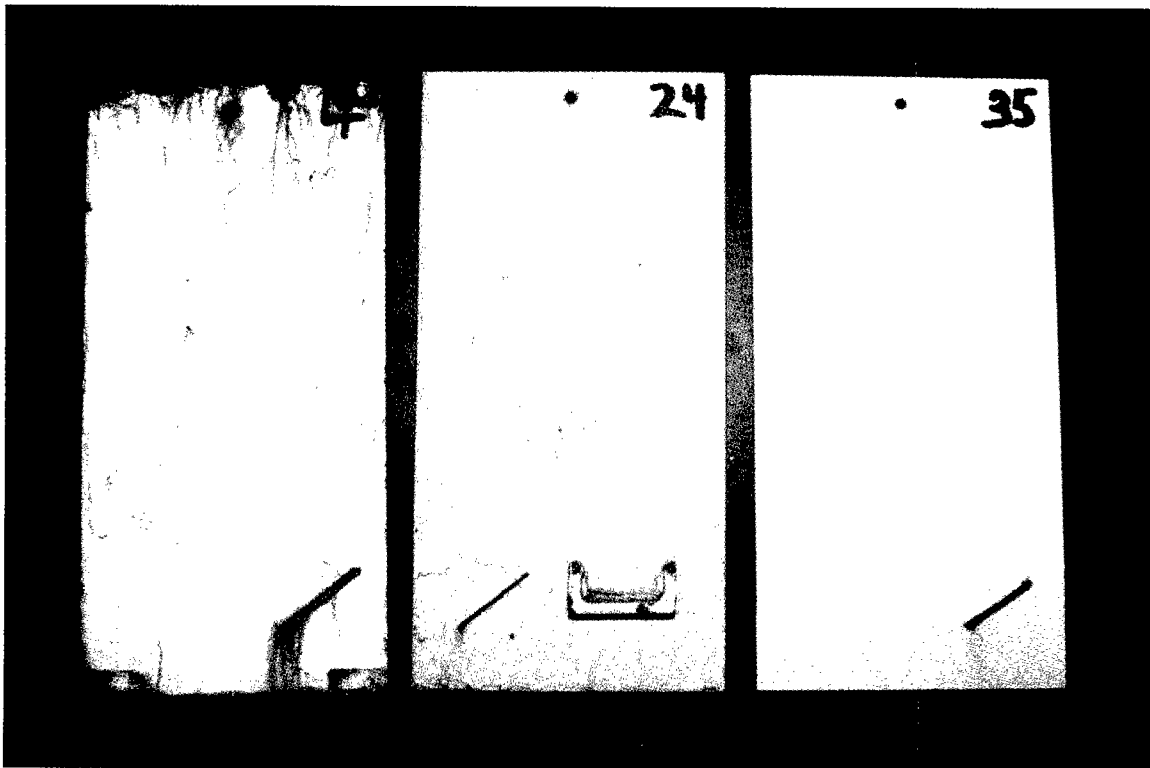
Figures 9 and 10 show some of the panels following the cyclic accelerated testing. On most of the panels the "islands" of intact coating that were painted over can be seen. The edges of these areas (transition from painting over old paint to painting over metal/rust) typically showed the most rusting. Other areas on the panels that frequently rusted were around the intentional scribe, the U-channel, and the edges of the samples. These are areas that were previously corroded and required overcoating over marginally cleaned bare steel. The rust stains caused by wet test conditions were considered cosmetic only. The actual deteriorated area that created the stains was rated and shown in figure 6.

Figure 9. Systems A (2-coat Al-alkyd), C (Calcium sulfonate alkyd), and F (epoxy mastic/urethane) applied over an aged IOZ/Vinyl system following the cyclic accelerated testing.

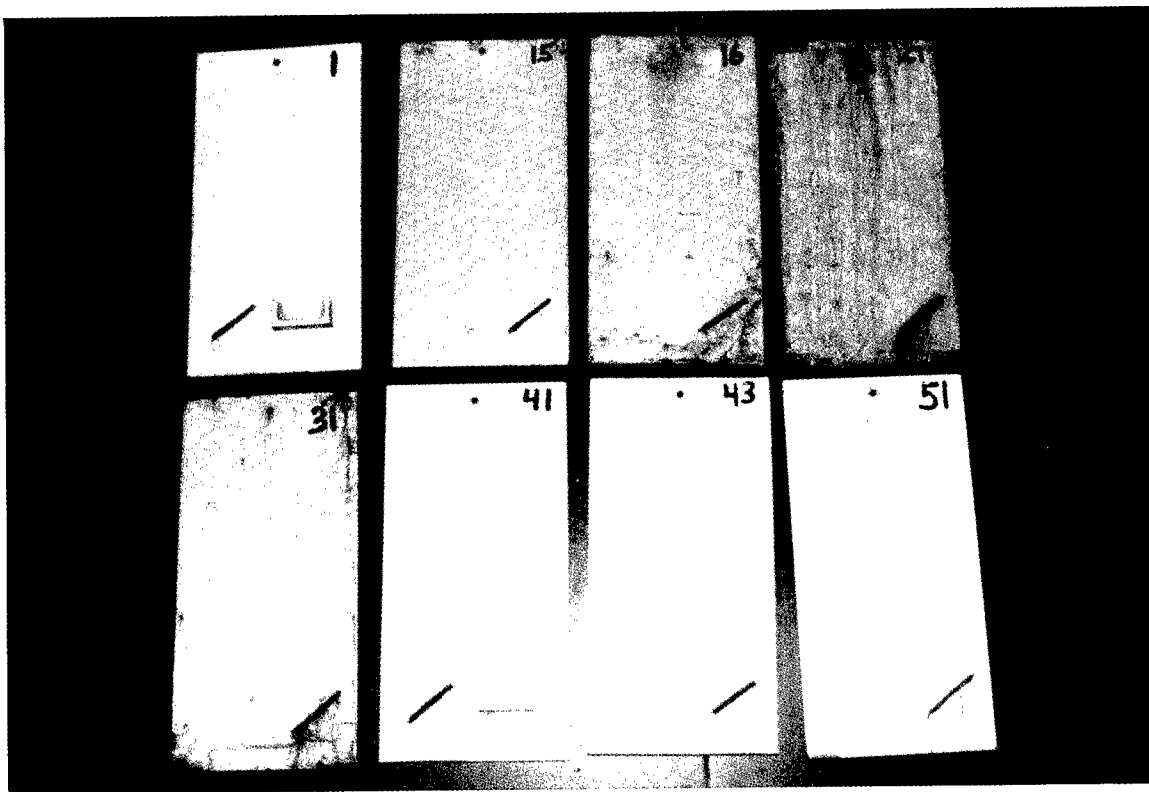
Figure 10. Six systems applied over an aged Basic Lead Silico Chromate coating system following the cyclic accelerated testing.

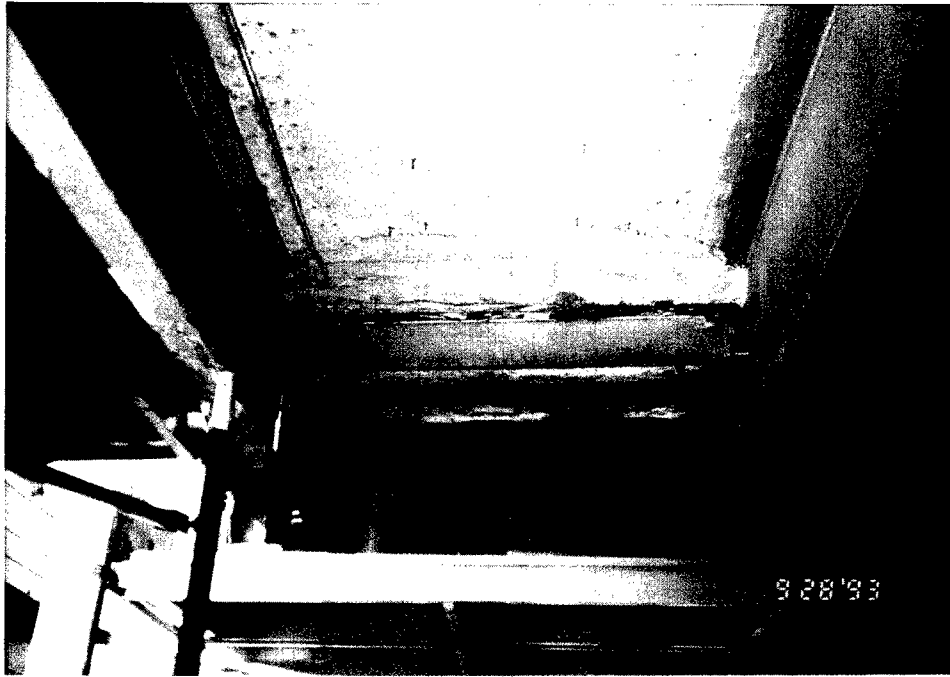
Figure 19. Initial condition of existing coating system at Chicago expansion joint.

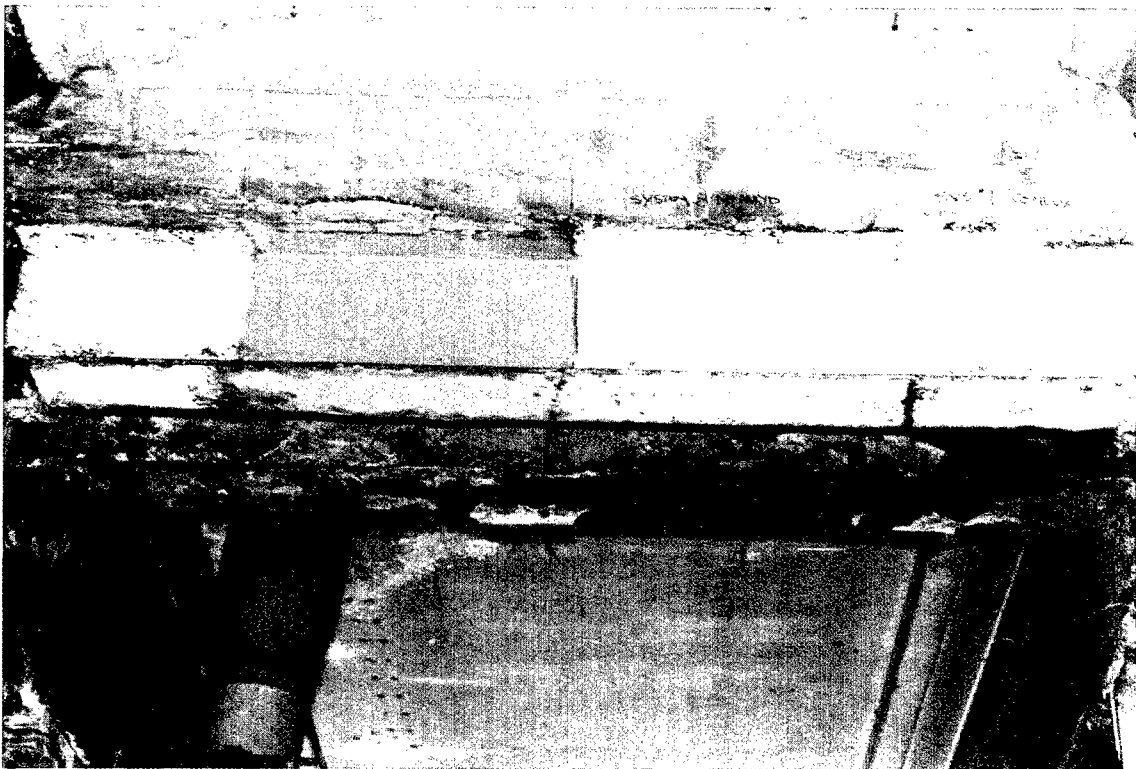
Figure 20. Chicago test patches applied to expansion joint area (2.5-year exposure, systems 5, 6, 8, and 1 from left to right).

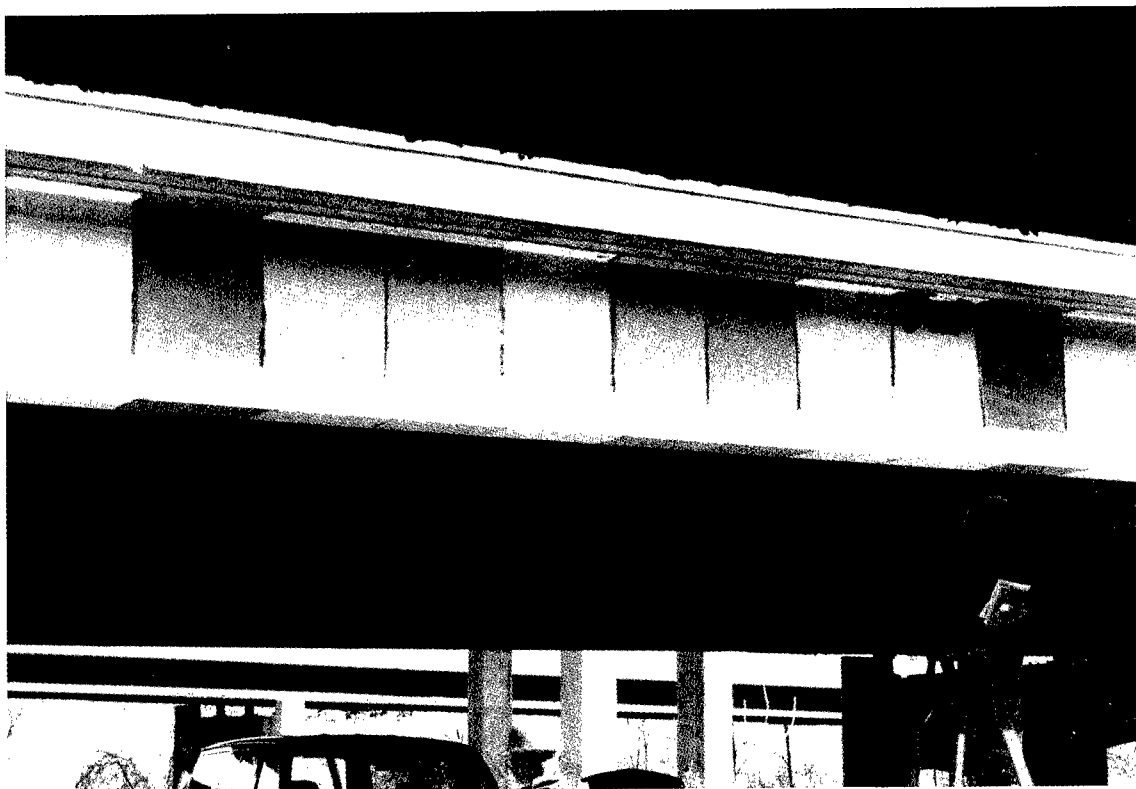
Figure 21. Overcoating test patches applied to Chicago facia girder (2.5-years exposure, ordered from left to right as in figure 18).

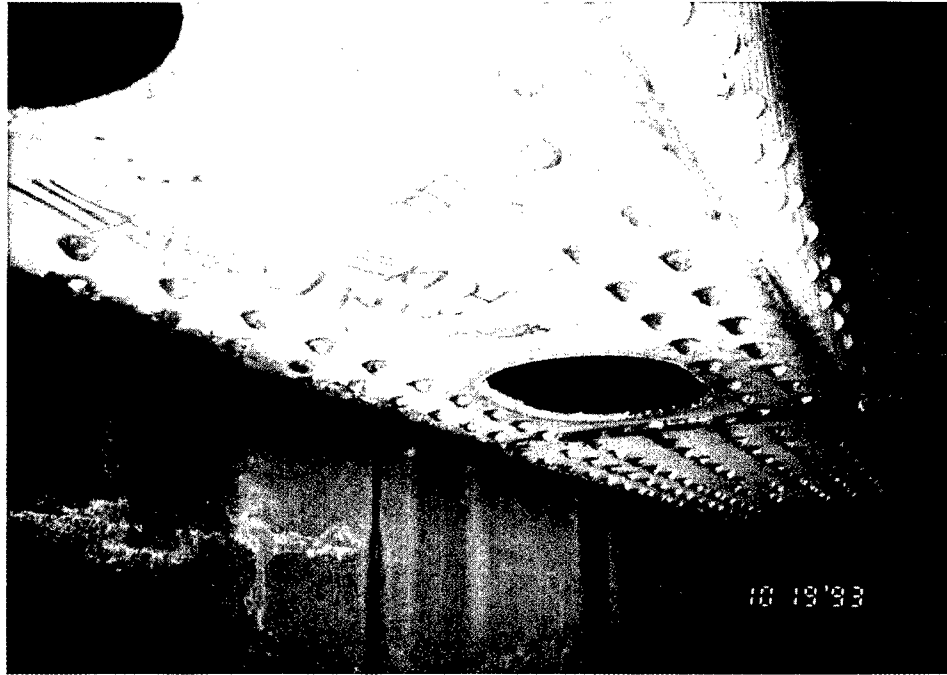
Figure 23. Initial condition of coating system on the bottom of the box-beam at the New York City location.

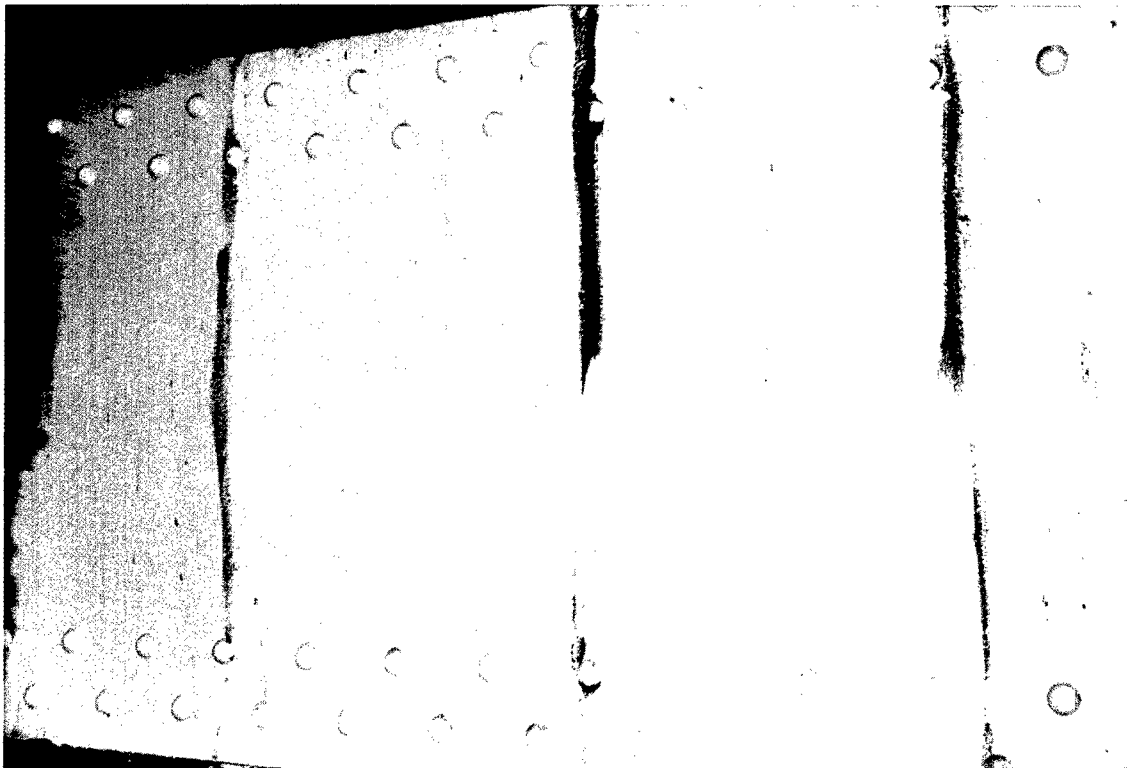
Figure 24. New York City test patches applied to expansion joint area (2.5-years exposure, left to right - systems 3, 1, 8, and 6).

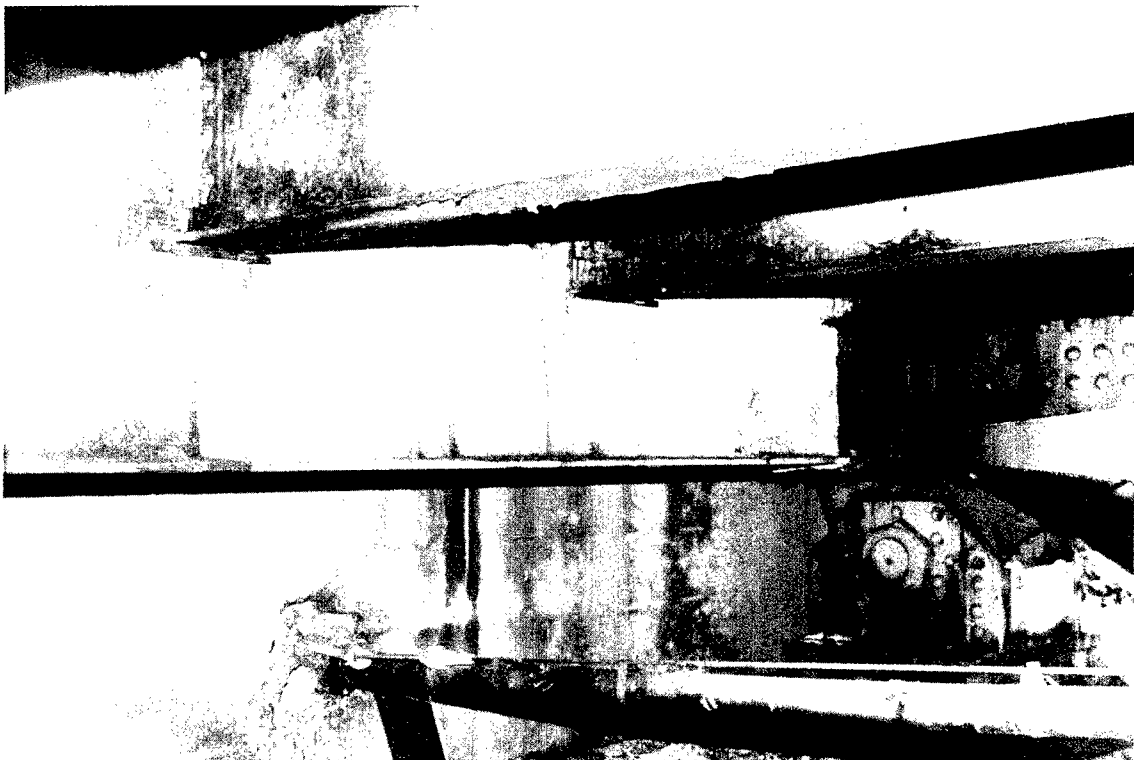
Figure 31 shows five of the test patches applied to the expansion joint area of the New Hampshire bridge following 1.5-years exposure. Frequent wetting of this beam from the expansion joint above has resulted in a severe environment for the test patch exposure. Most of the areas that were originally corroded (figure 17) have begun to re-rust during the 1.5-year exposure. The inspection results presented in table 8 will help differentiate the corrosion performance of the overcoating systems.

Figure 31. New Hampshire bridge test patches under the expansion joint after 1.5 years exposure (systems 11, 12, 6, 3, and 8).
